FTI-NSP2 Type 1 - Installation Notes & Wiring Diagram

FTI-NSP2 Type 1

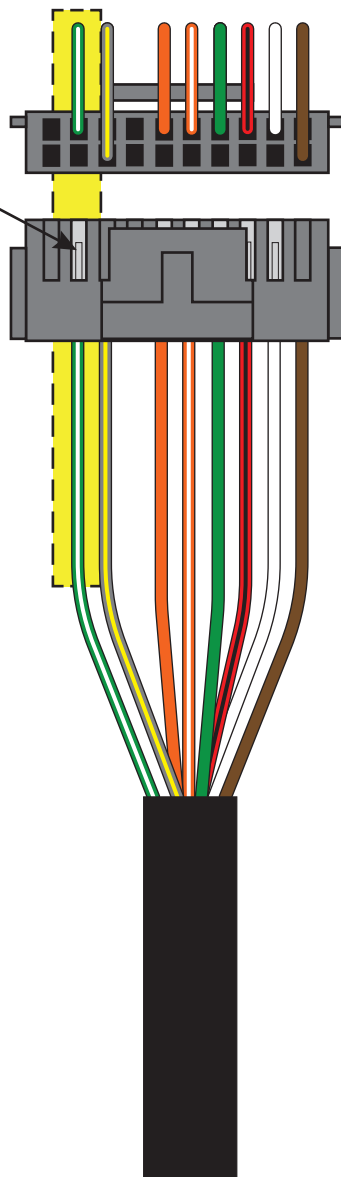
Figure 1: Incorrect placement

Overview: The initial production release of the FTI-NSP2 harness has an issue where the POC1 circuit is incorrectly positioned in the CM7 I/O connector. This issue affects only the gray 20-pin CM7 I/O connector illustrated below in figure 1.

Issue: The green/white parking light circuit is positioned in pin position #17, the fixed light output where the green/white wire is typically placed for parking lights, but the harness solution uses the vehicle hazard lights instead, the result when used as supplied is an erratic light display.

- 1.) Use a pick tool to depress the locking tab on the terminal connector of the green/white wire
- 2.) Remove wire and prepare to reposition
- 3.) Once removed, reposition the locking tab by using a razor knife to lift the tab into a usable position
- 4.) With locking tab repositioned, relocate to pin position #1 (top right position as illustrated)
- 5.) Push the terminal connector into the I/O connector housing until the locking tab clicks into place and the wire is secure
- 6.) Correction complete, you may now complete the installation, but remember to configure POC1 for Hazards (setting #30)
