FTI-FTI-NSP2 Type 2 - Vehicle Coverage & Preparation Notes

RSTECH, LLC.

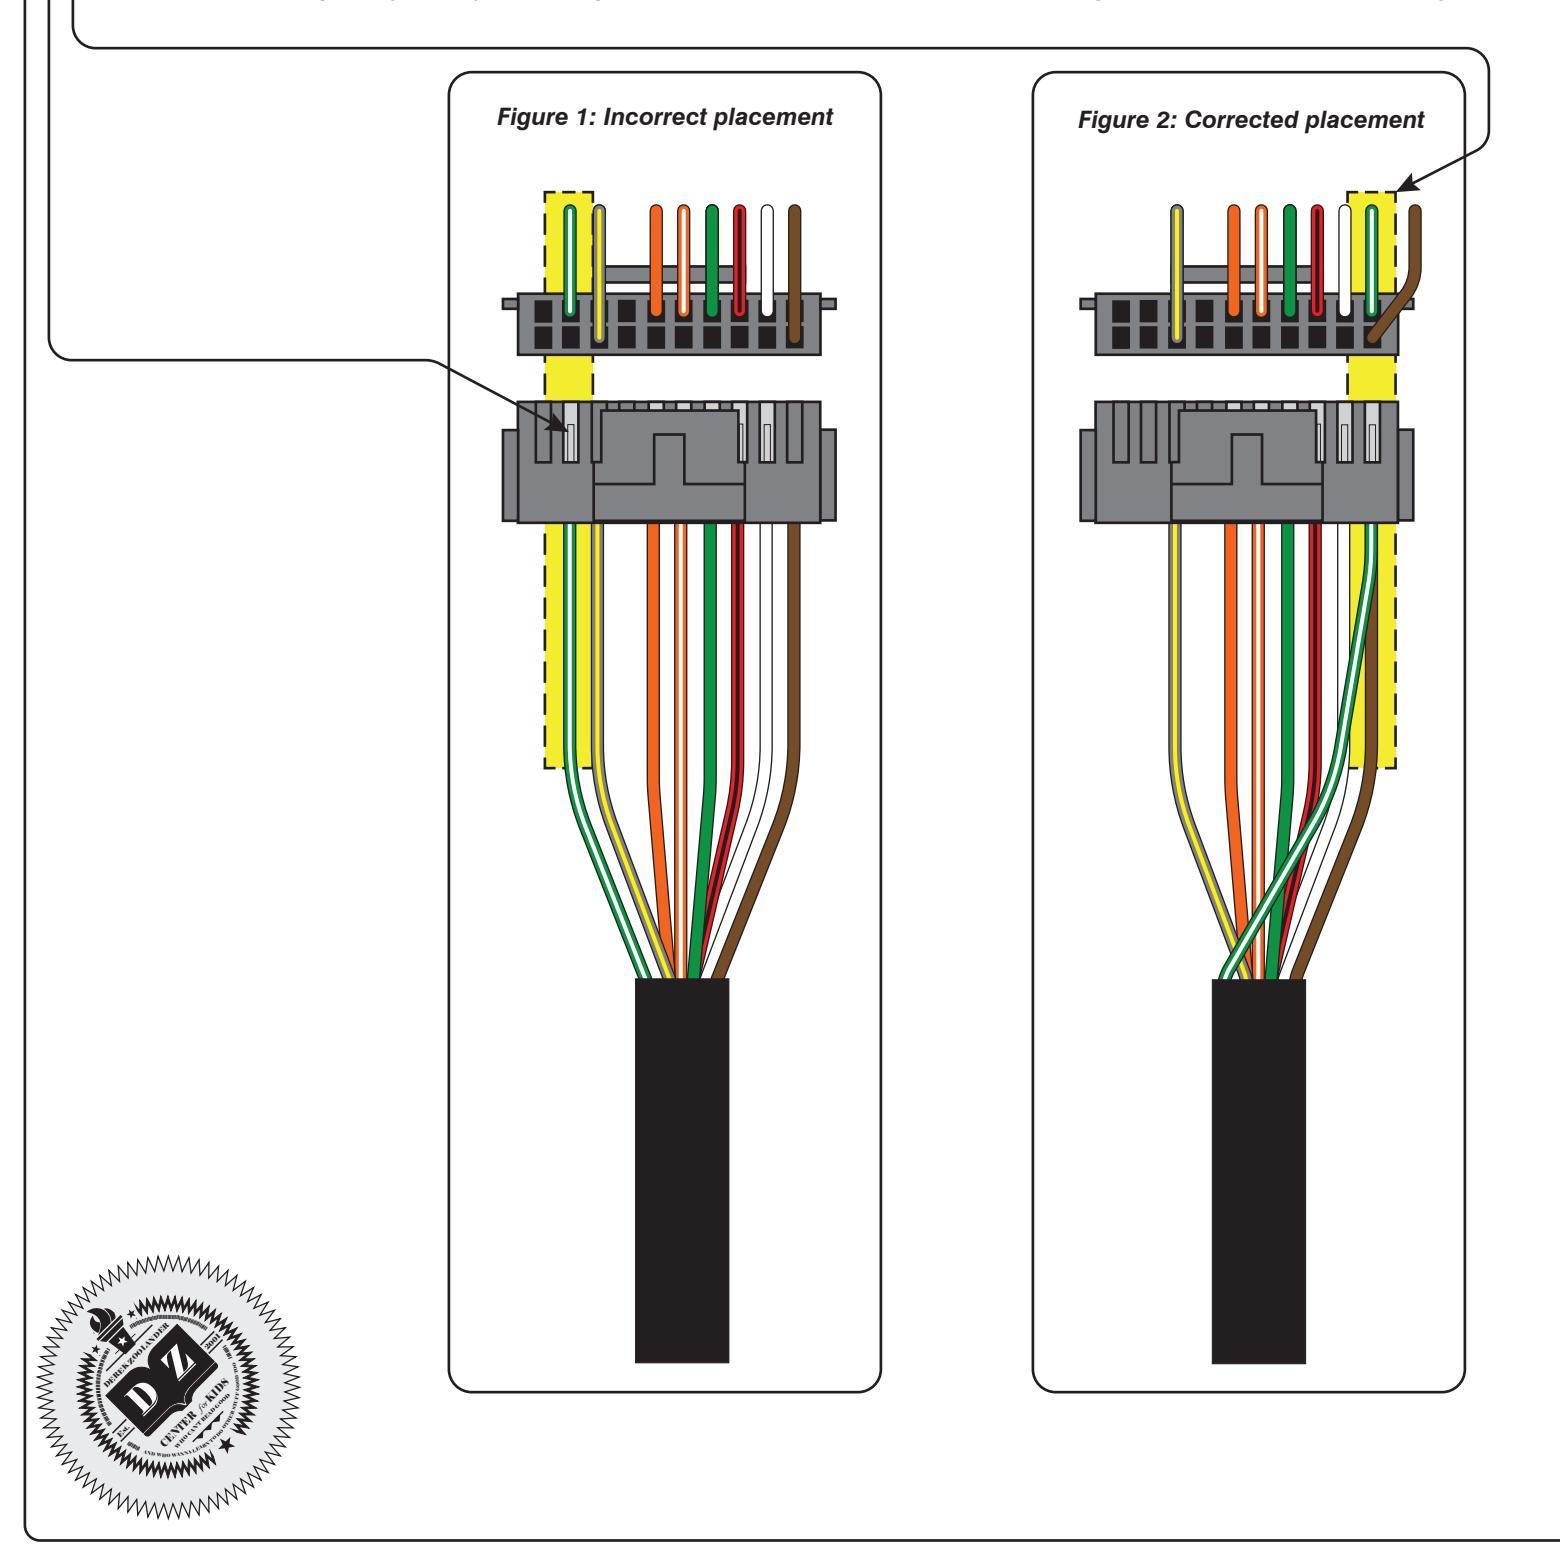
Overview: The initial production release of the FTI-NSP2 harness has an issue where the POC1 circuit is incorrectly positioned in the CM7 I/O connector. This issue affects only the gray 20-pin CM7 I/O connector illustrated below in figure 1.

Issue: The green/white parking light circuit is positioned in pin position #17, the fixed light output where the green/white wire is typically placed for parking lights, but the harness solution uses the vehicle hazard lights instead, the result when used as supplied is an erratic light display.

- 1.) Use a pick tool to depress the locking tab on the terminal connector of the green/white wire
- 2.) Remove wire and prepare to reposition
- 3.) Once removed, reposition the locking tab by using a razor knife to lift the tab into a usable position
- 4.) With locking tab repositioned, relocate to pin position #1 (top right position as illustrated)
- 5.) Push the terminal connector into the I/O connector housing until the locking tab clicks into place and the wire is secure
- 6.) Correction complete, you may now complete the installation, but remember to configure POC1 for Hazards (setting #30)
