FTI-FTI-NSP2 Type 3 - Vehicle Coverage & Preparation Notes

FTI-NSP2 Harness Bulletin - Mis-wired POC1 (parking lights)

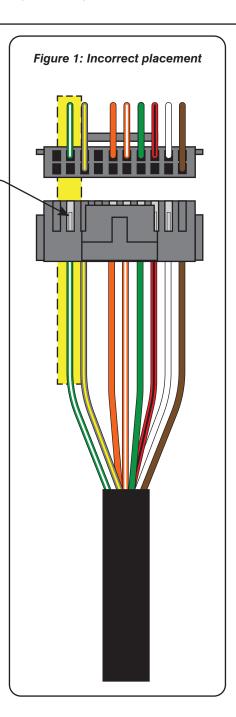
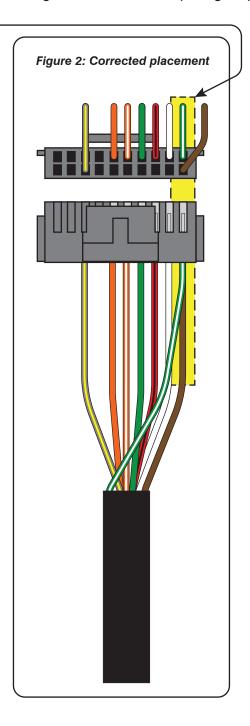
Overview: The initial production release of the FTI-NSP2 harness has an issue where the POC1 circuit is incorrectly positioned in the CM7 I/O connector. This issue affects only the gray 20-pin CM7 I/O connector illustrated below in figure 1.

Issue: The green/white parking light circuit is positioned in pin position #17, the fixed light output where the green/white wire is typically placed for parking lights, but the harness solution uses the vehicle hazard lights instead, the result when used as supplied is an erratic light display.

- 1.) Use a pick tool to depress the locking tab on the terminal connector of the green/white wire
- 2.) Remove wire and prepare to reposition
- 3.) Once removed, reposition the locking tab by using a razor knife to lift the tab into a usable position
- 4.) With locking tab repositioned, relocate to pin position #1 (top right position as illustrated)
- 5.) Push the terminal connector into the I/O connector housing until the locking tab clicks into place and the wire is secure
- 6.) Correction complete, you may now complete the installation, but remember to configure POC1 for Hazards (setting #30)
